VEHICLE DOSSIER

SELECTION / FT 001

JAGUAR  
**F-TYPE**

3.0 V6 SUPERCHARGED  
COUPÉ / AWD / R-DYNAMIC

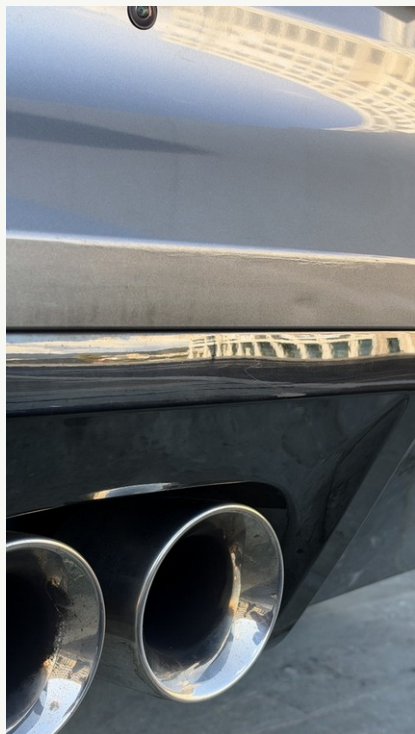
**C05 / Rear bumper**

An uneven finish is visible in the photograph. The owner reports previous touch-up work.

Uneven finish.  
P / Previous touch-up work  
reported by the owner.

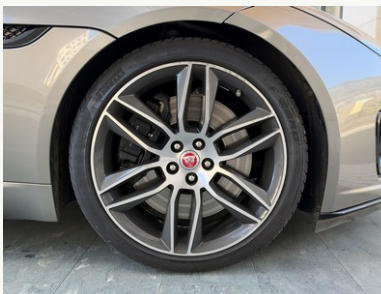
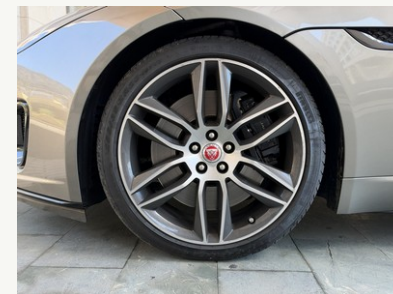
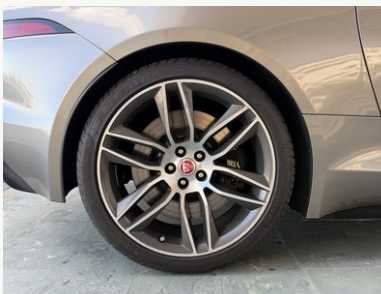
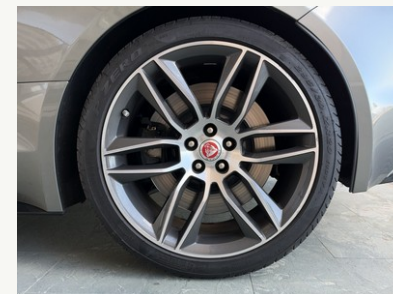
**C01–04 / All four wheels**

Cosmetic marks on all four wheels, visible in the close-up photographs on page 15.

Cosmetic marks visible in the close-up photographs.

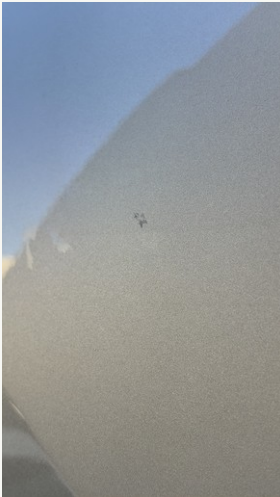
## C06 / Body side

A very small surface mark on the body side, shown in the close-up photograph on page 16.

A very small surface mark on the body side, shown in the close-up photograph.

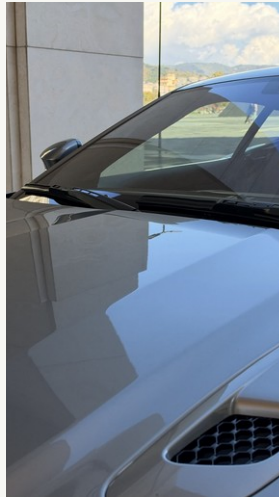
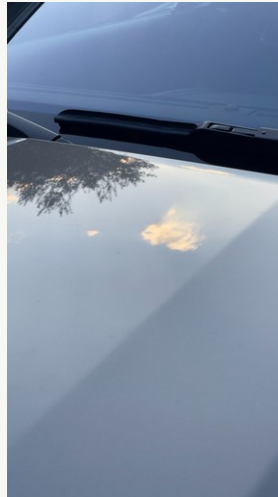
## C07 / Bonnet

A small depression in the bonnet, shown in an overview and close-up on page 16.

A small depression identified by the owner. Overview and close-up of the same area.

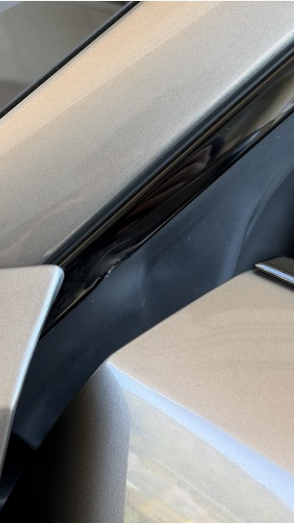
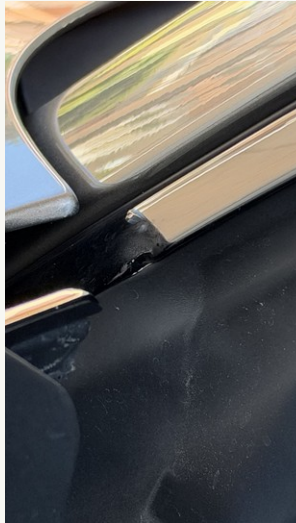
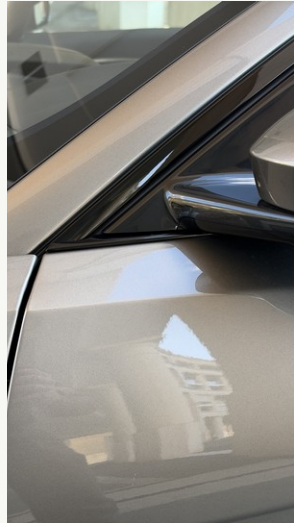
## C09 / Left front door aperture

Deformed trim on the left front door aperture, in an area concealed when the door is closed. Context and close-up views on page 17.

Deformed trim on the left front door aperture, in an area concealed when the door is closed.

An attempted theft damaged the left front door glass and interior trim on the driver's side. The police received the report on 8 July.

On 31 July, PDM, part of the official Jaguar network, replaced the left front door glass with a genuine part. The police report and repair invoice are available from the owner on request.

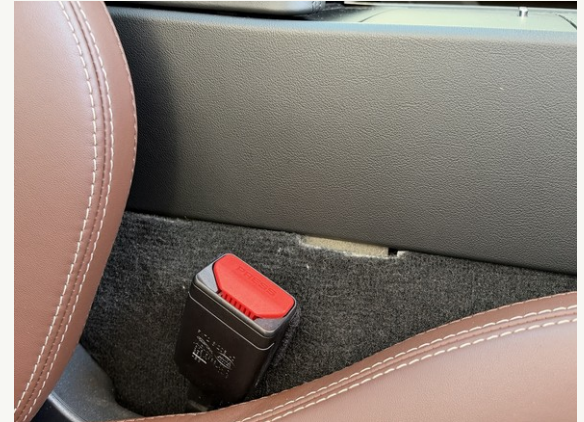
## C10 / Centre tunnel carpet

The carpet's upper edge exposes part of the underlying backing beside the seat. Photograph on page 17.

The carpet's upper edge exposes part of the underlying backing beside the seat. The photograph shows the area in context, without attributing a cause.
